## INVENTORY INSPECTION REPORT

# COLEBROOK LAKE SERVICE BRIDGE COLEBROOK LAKE DAM COLEBROOK, CT

MAY 1995

DEPARTMENT OF THE ARMY  
NEW ENGLAND DIVISION, CORPS OF ENGINEERS  
COLEBROOK RIVER SERVICE BRIDGE  
INVENTORY INSPECTION

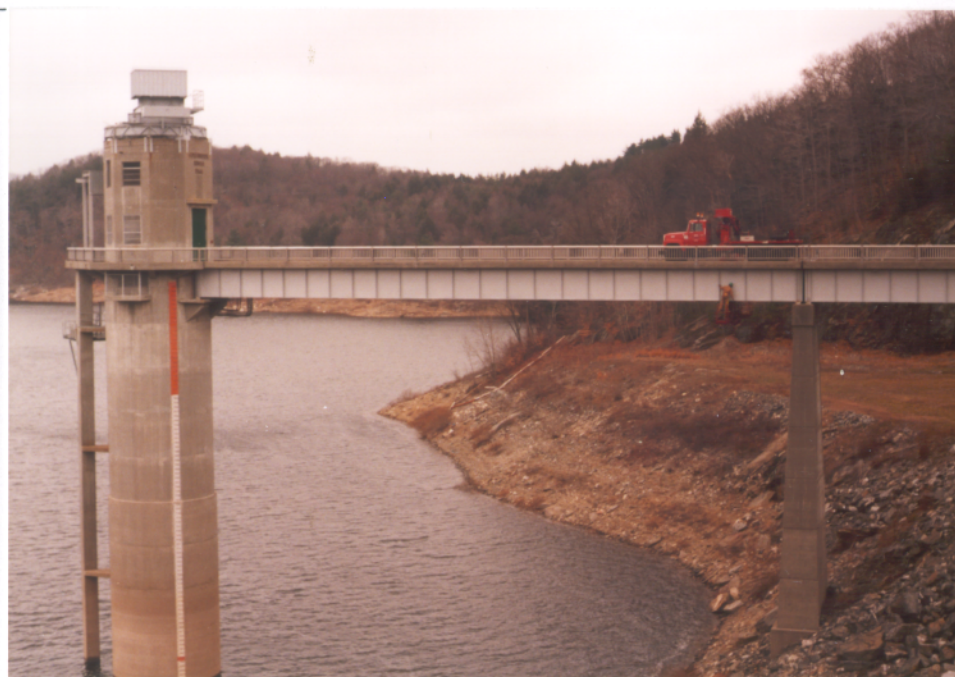
②

DESCRIPTION: TYPICAL PROCEDURE FOR CLOSE-UP INSPECTION OF  
SUPERSTRUCTURE.

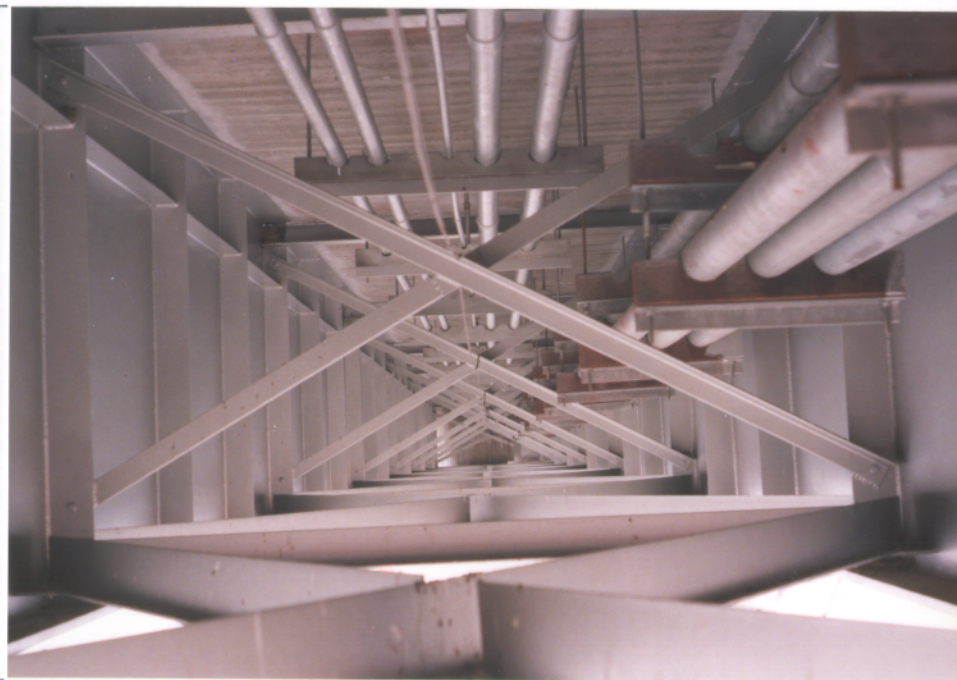
6

The bridge superstructure was generally in good condition (see Report Photo 6). Isolated locations of distress on the superstructure elements are noted as follows:

DESCRIPTION: SUPERSTRUCTURE FRAMING LOOKING WEST.

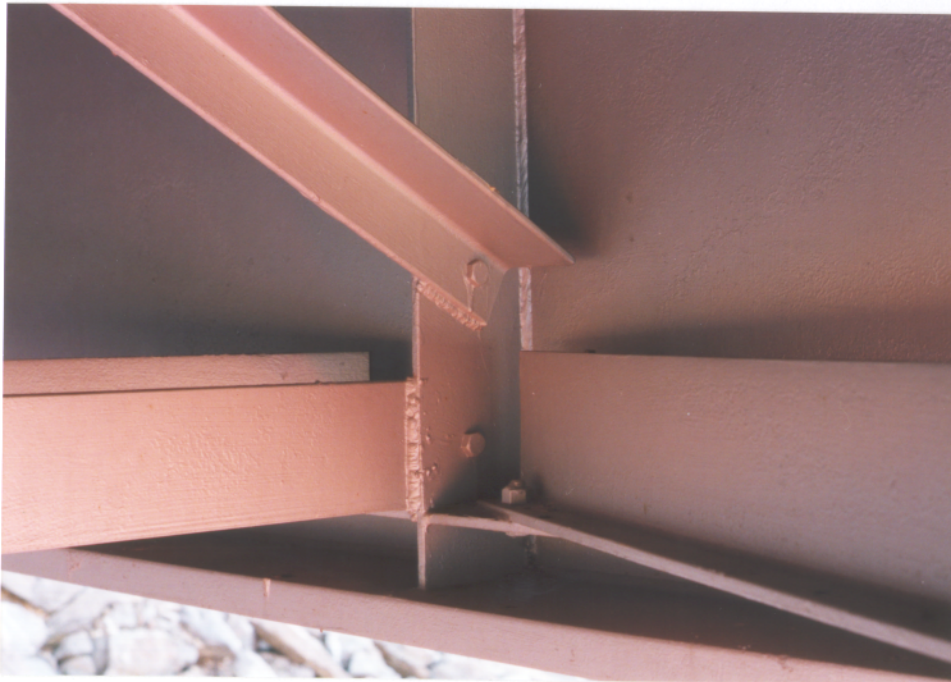
9

The cross frames between girders were generally in good condition with no defects observed (see Report Photo 9).

DESCRIPTION: TYPICAL GIRDER TO CROSS FRAME LOWER WELDED CONNECTION.

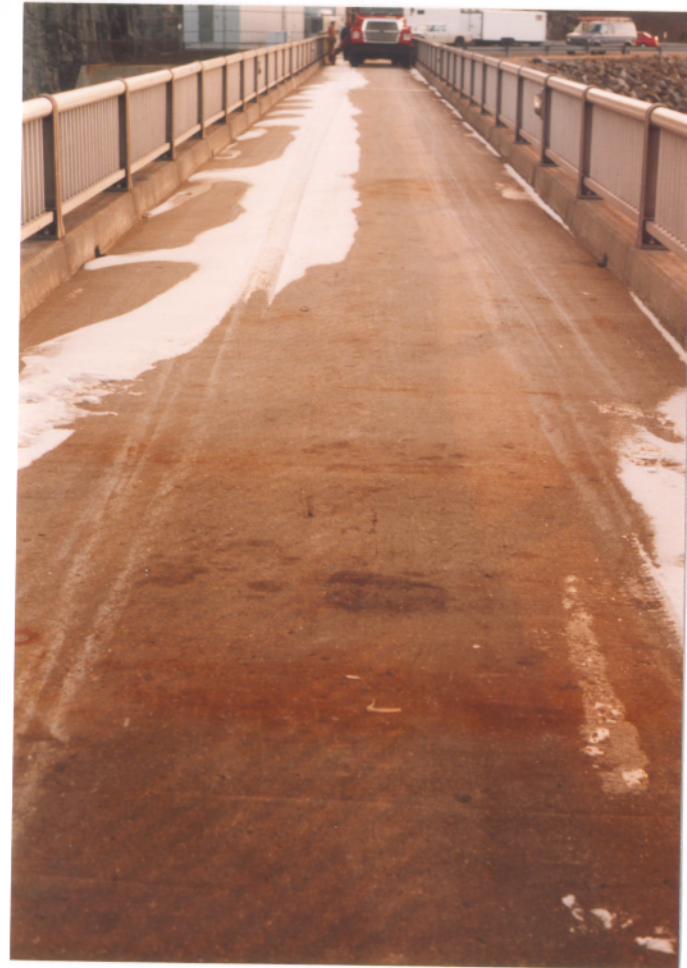
10

The deck was generally in good condition with minor areas of concrete distress observed (see Report Photo 10). The following is a summary of the condition findings:

DESCRIPTION: BRIDGE DECK LOOKING EAST.

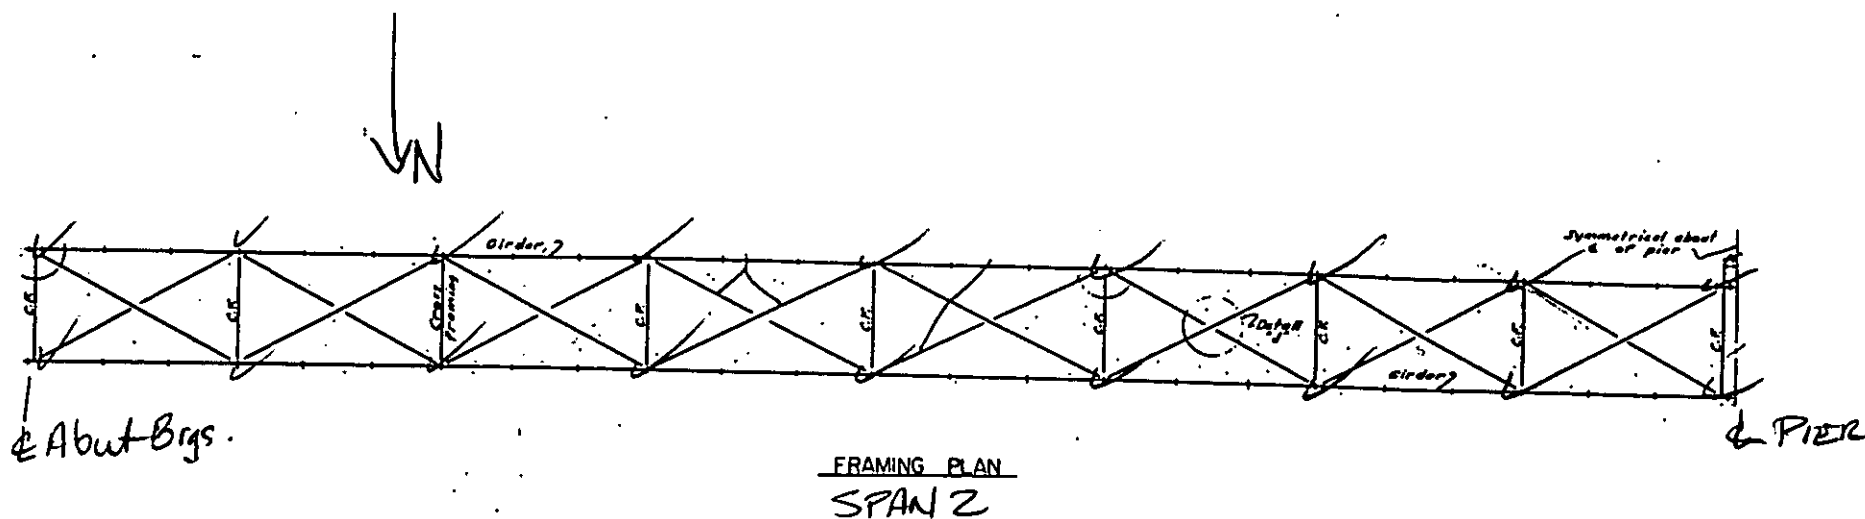
CREW: RWH, B, BH SHEET 2 OF 7

NOTES: Typ. Conditions: - All framing o.k. except as noted on  
 North Girder Elev. sheet, Span 2 (Sht. 7 of 17)  
 - Underside of deck displays chair rust staining  
 otherwise in good condition

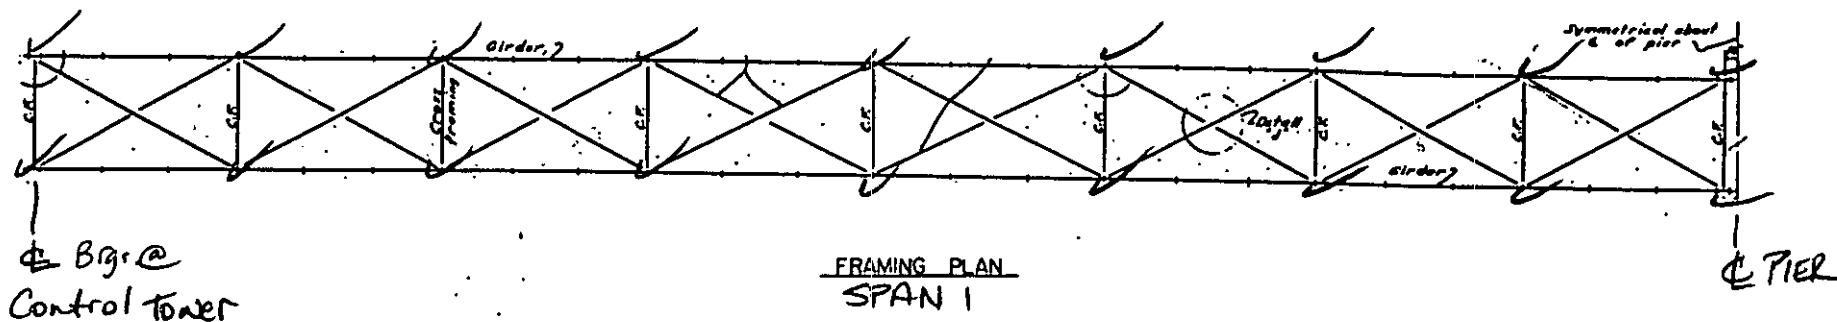
JOB #1784      DATE: 1/25/25  
 CREW: BH, PWN, PG      SHEET 3 OF 7

NOTES: Typ. Cond. - All Framing O.K.

- Underside of deck displays chair rust stains, otherwise in good condition.
